**NUWER LAKE DAM
OREGON COUNTY, MISSOURI
MO 30190**

PHASE 1 INSPECTION REPORT NATIONAL DAM SAFETY PROGRAM

Name of Dam:	Nuwer Lake Dam
State Located:	Missouri
County Located:	Oregon
Stream:	Unnamed Tributary of Frederick Creek
Date of Inspection:	June 18, 1980

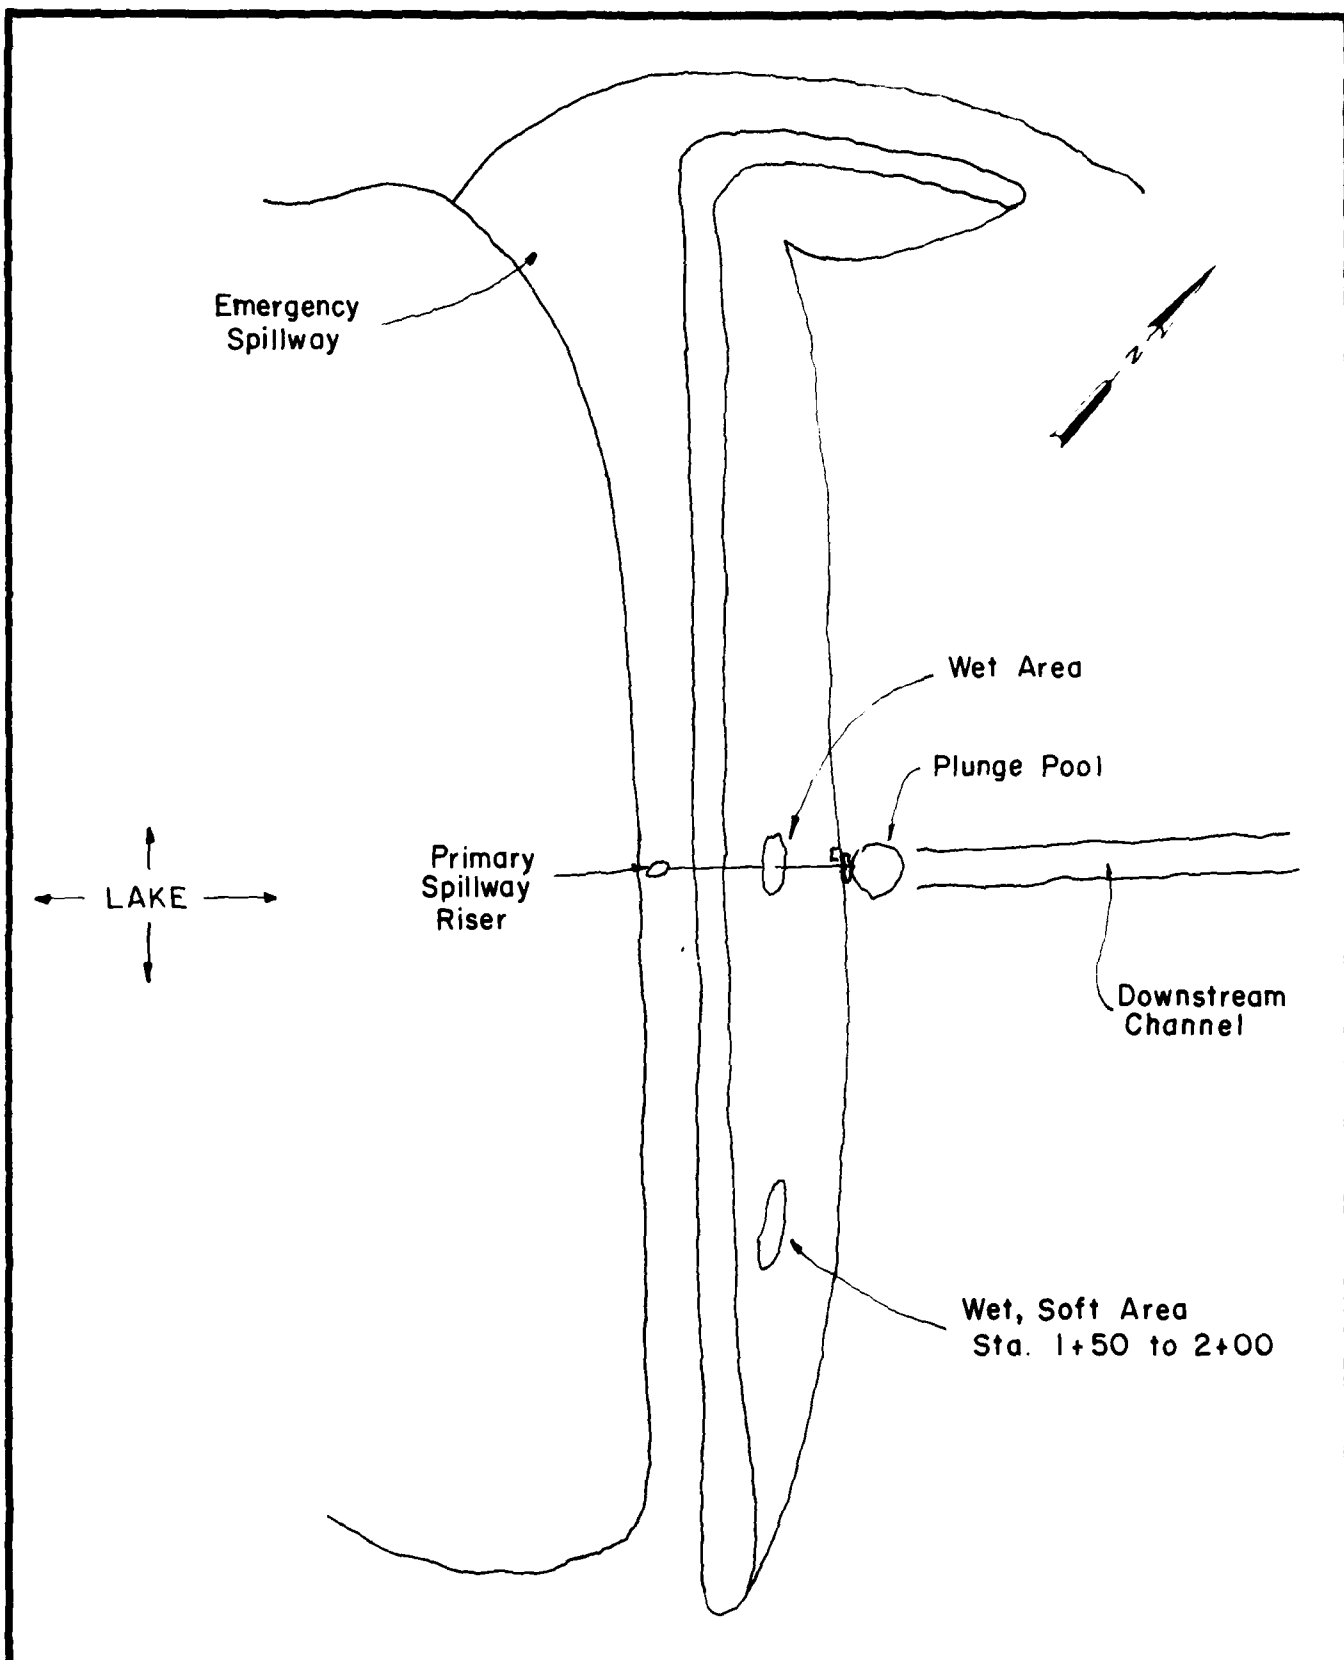
PLAN SKETCH OF FEATURES

Shallow auger probes into the embankment indicated the dam to consist of reddish brown clayey silt to silty clay with chert fragments (ML-CL). Information from the owner indicates that material for construction of the dam was obtained from a knob upstream of the dam on the left side, from the emergency spillway excavation, and from the lake area. Sheet 7 of Appendix A presents a plan sketch of the dam showing observed features.
